Wind Turbine Gearbox Save

A Failure Reported by the Gearbox Manufacturer

Application: Wind Turbine Gearbox – Serial No. 421.903.143-001-3

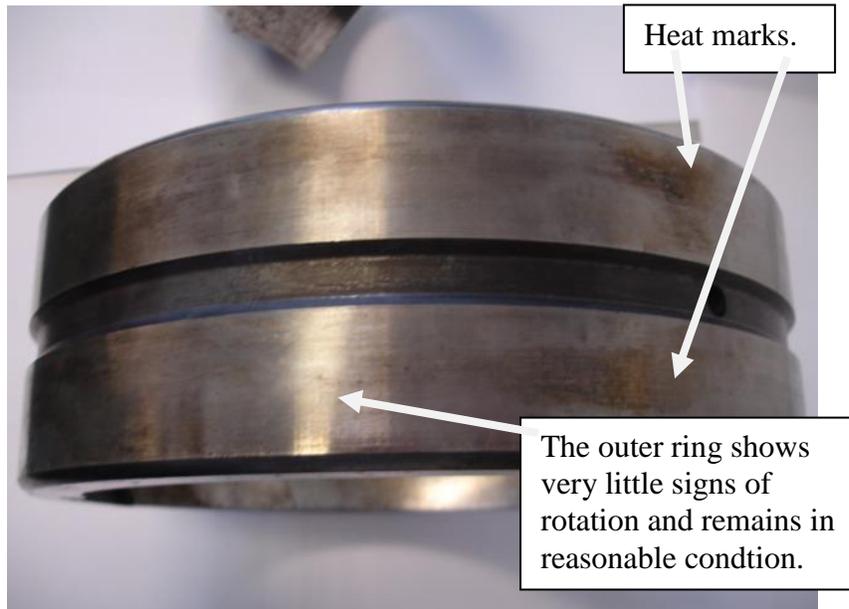
Outer Ring

The outer ring remains in a reasonable condition, indicating very little signs of rotation within the housing. The heat generated marks could have been caused during removal after collapse of the bearing. No fretting has occurred between the outside diameter of the outer ring and the housing.

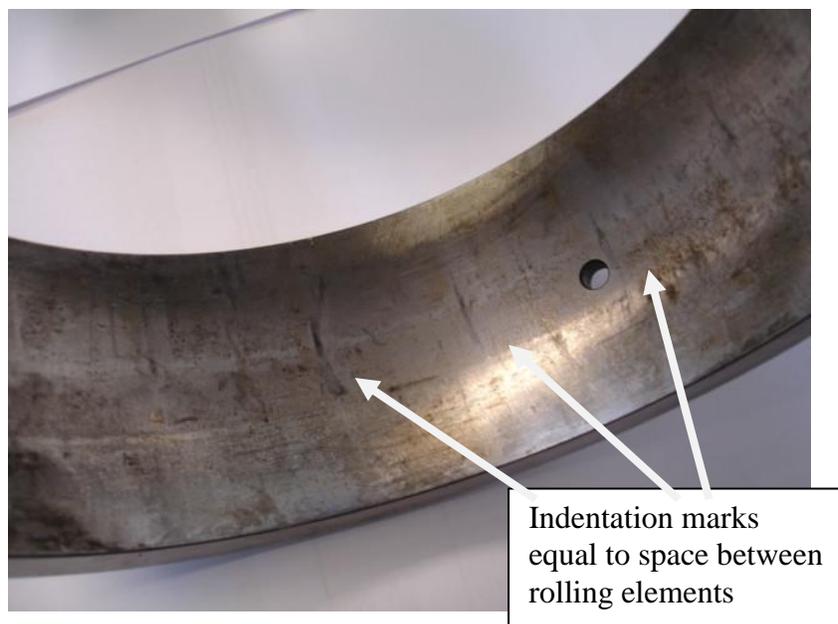
Outer Ring Raceway

The outer ring raceway shows small indentations and spalling equal to the spacing of the rolling elements. In addition, we see some signs of discoloration from the lubrication.

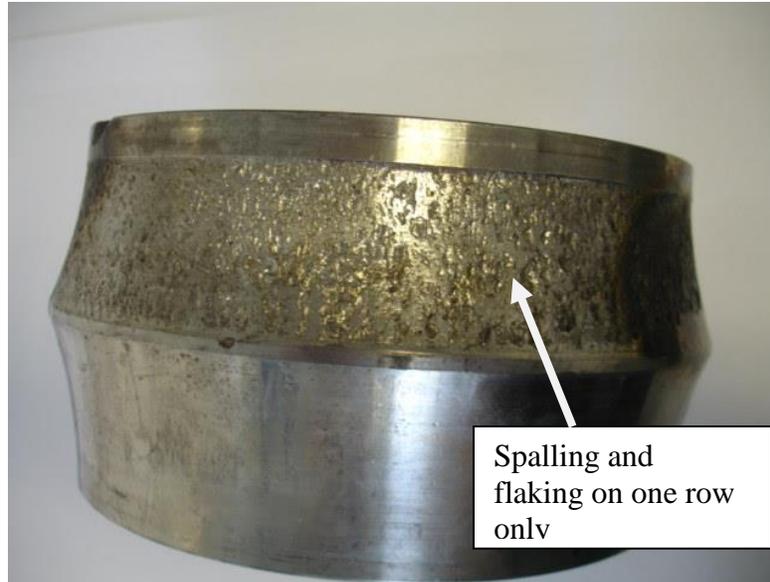
Inner Ring Raceway

The inner ring raceway has spalling and flaking on one row only. The opposite row has no damage.

The fact that the spalling occurred on only one row further tends to point to the conclusion that the damage has occurred when the bearing has been stationary.

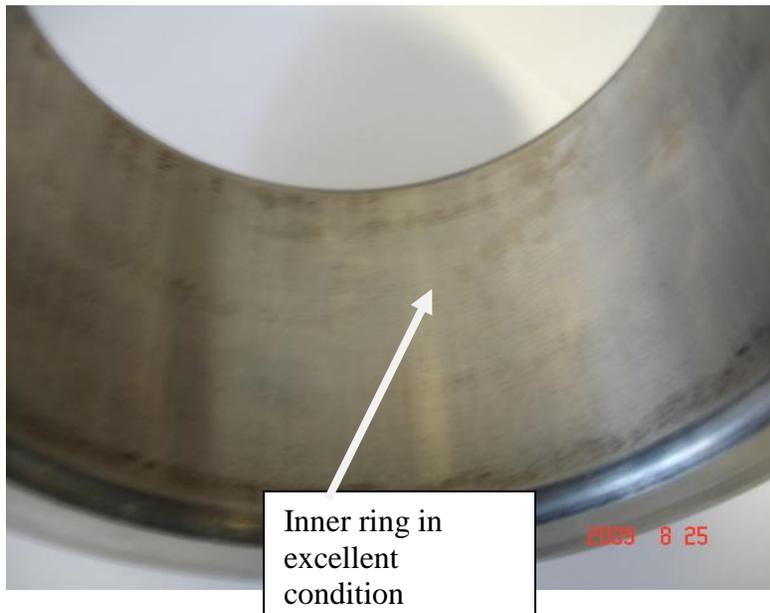
Inner Ring Bore

The inner ring bore shows no signs of any damage and no fretting has occurred between the shaft and the inner ring.

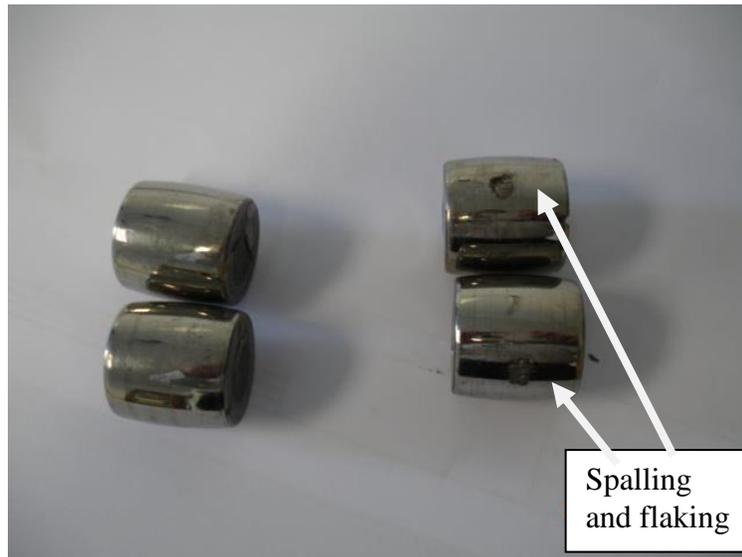
Rolling Elements

The rollers on one side have flaking and spalling. There is no sign at all of any polishing or any other damage.
