# Bearing Wear Example #1 – Inner Race Fault
Alan Friedman – DLI Engineering

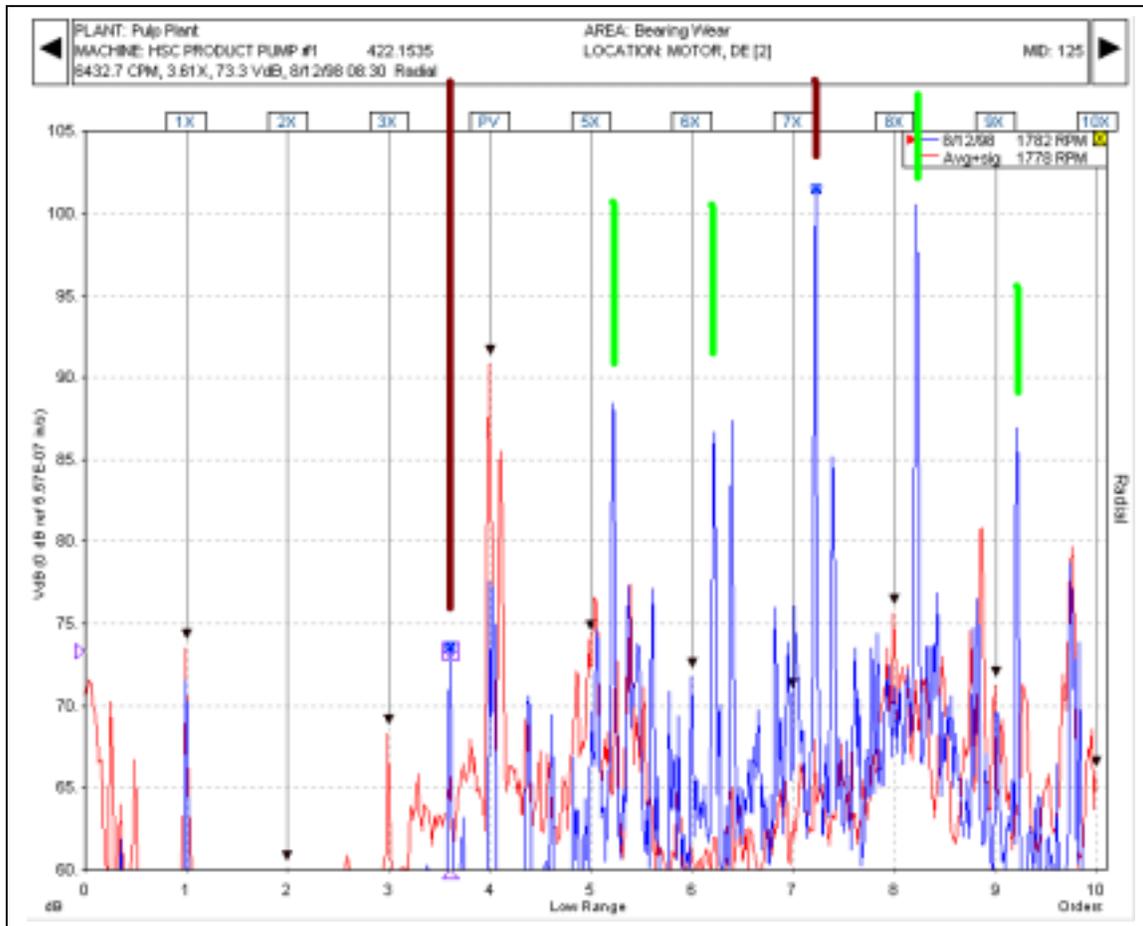
(Figure 1, Vibration Data – Motor End)

The red colored spectrum is a prior measurement from the same machine, which is used as a reference; the blue colored spectrum is the latest data. Without knowing anything about vibration analysis it is obvious that there are peaks in the blue spectrum that were not in the red spectrum. This is our first clue that something has changed.

The horizontal axis of this graph is in "orders" where "1" indicates the running speed of the machine. The first rule about bearing tones is that they rarely appear at frequencies that are exact multiples of the shaft rate. As we can see, many of the large peaks in the blue spectrum do not line up with shaft multiples.

The peak on the left marked with the maroon line falls at a frequency of 3.61x the shaft rate. This is a fundamental bearing tone, and we can see a harmonic of this tone, also marked in maroon, at 7.22x.

If we measure the distance on the graph between 0 and 1 on the horizontal axis with a scrap of paper, we will have a measurement of the shaft frequency of the machine. Moving the marked scrap of paper over to the peak at 7.22x, we can see that the peaks marked with green lines are separated from the peak at 7.22x by the run speed of the machine (they are at frequencies of 5.22x, 6.22x, 8.22x, 9.22x). These peaks are called "1x sidebands" and are caused by a fault in the bearings' inner race traveling in and out of the load zone with every shaft revolution. If one considers that the weight of the horizontal shaft is at the bottom of the machine, it will be clear that as a fault on the inner race travels down, it hits the balls harder. When the fault on the inner race is at the top of the machine, it hits the balls more softly. This repetitive change in the impact forces is called amplitude modulation, and this is what causes the 1x sidebands. If we take the same scrap of paper and place it by the peak at 3.61x, we will see that this peak also has 1x sidebands, although they are not marked on the graph.

The presence of 1x sidebands is common to bearing wear (when the fault is on the inner race) and therefore the existence of these sidebands confirms that these tones are in fact bearing related. If this vibration were coming from another machine next to the one we are examining for instance, it would not create this pattern of 1x sidebands, thus we can rule out external vibration.

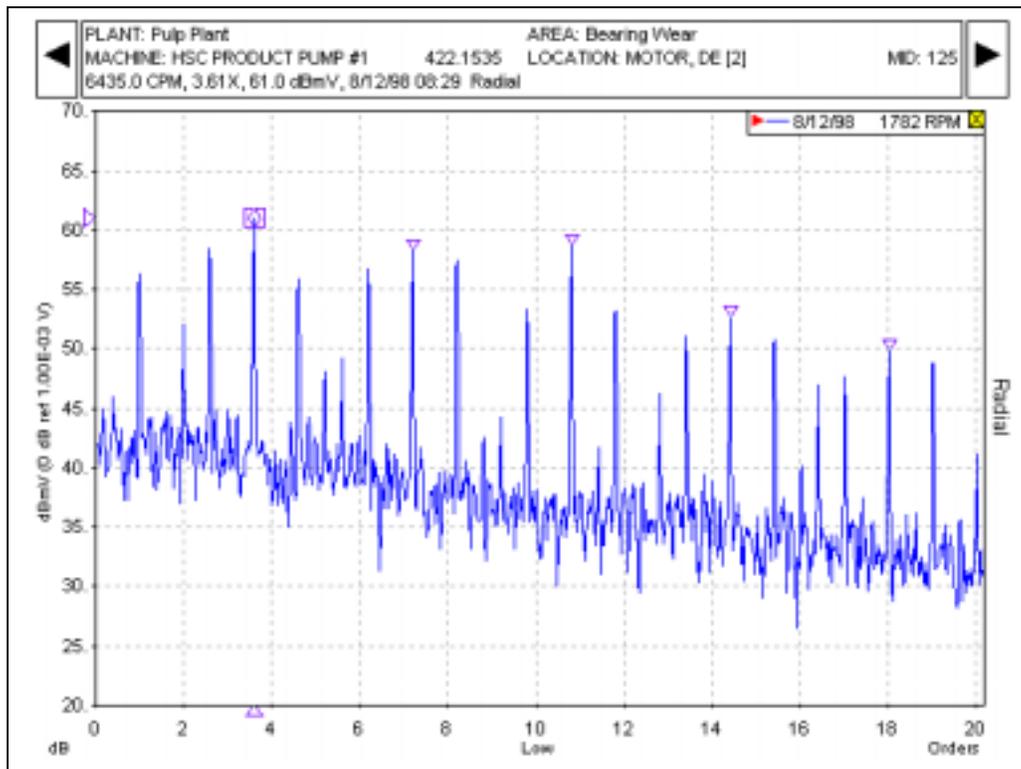
(Figure 2, Demodulated Data - Motor End)

Although we currently have more than enough evidence to confirm that this is in fact a bearing problem, a high frequency enveloping measurement (often called demodulated data) provides additional confirmation. As we shall soon see, this measurement also confirms that the bearing problem is on the motor end of the machine, not the pump end. The spectrum in figure 2 above is the demodulated spectrum from the motor end of the machine. Here we can see the same 3.61x peak (and harmonics) that we see in the spectrum in figure 1.

Because demodulated data results from a high frequency measurement, it is more sensitive to location. This is because high frequency vibration cannot travel as far and probably will not travel through a flexible coupling.

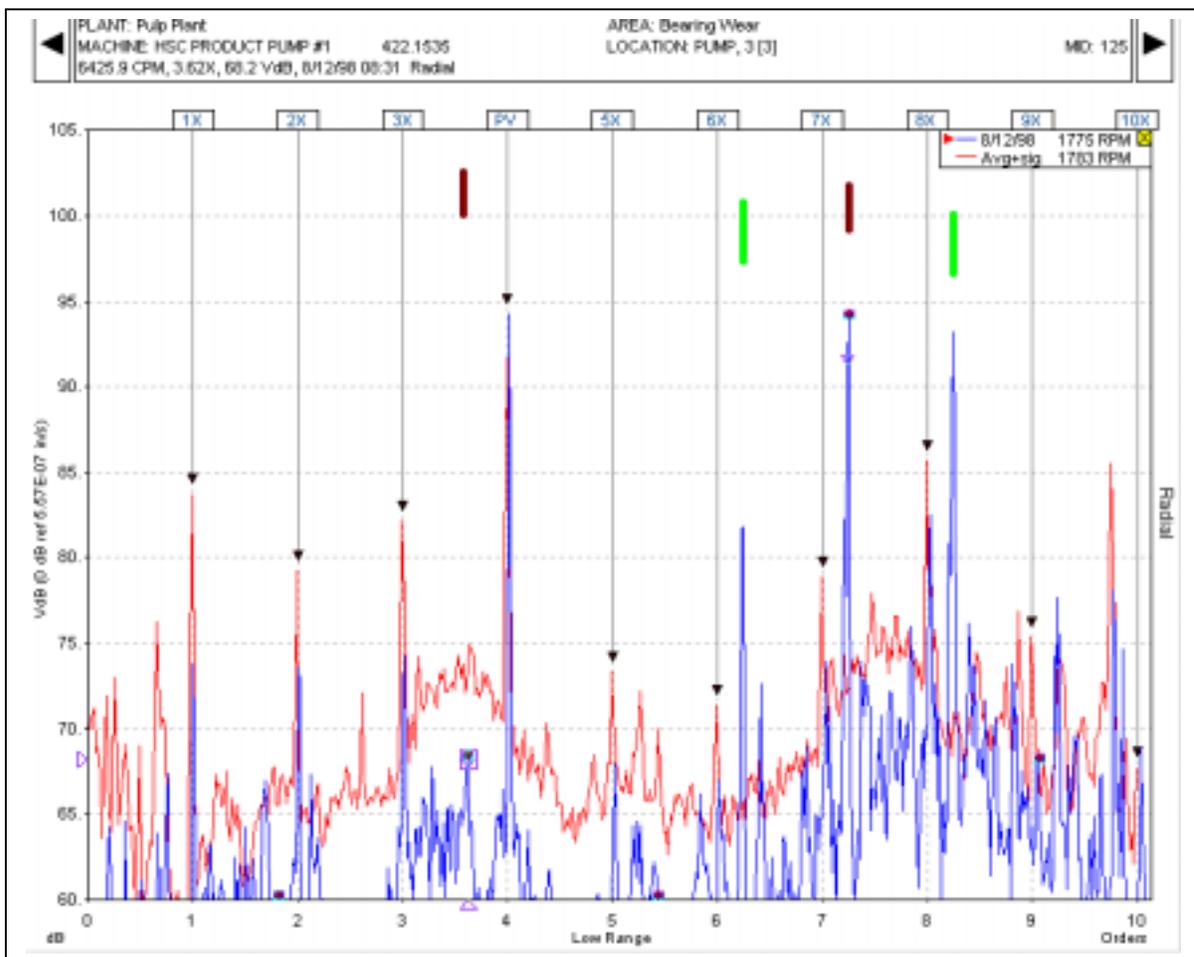
(Figure 3, Vibration Data - Pump End)

In figure 3 above, we can see that the same peaks marked in maroon at 3.61x and 7.22x that we saw on the motor end of the machine, as well as the 1x sidebands marked in green. If we had not already looked at the demodulated data, it would be difficult to determine at this point whether it is in fact a pump bearing or motor bearing that has a fault, since the vibration is apparently able to travel from one part of the machine to the other.

If demodulated data were not available, one could check calculated bearing frequencies to see if these tones coincide with expected failure frequencies (assuming the pump and motor have different bearings in them), or, one could make an assumption that the vibration levels should be higher the closer one is to the faulty bearing. Unfortunately, the latter assumption is not always correct.

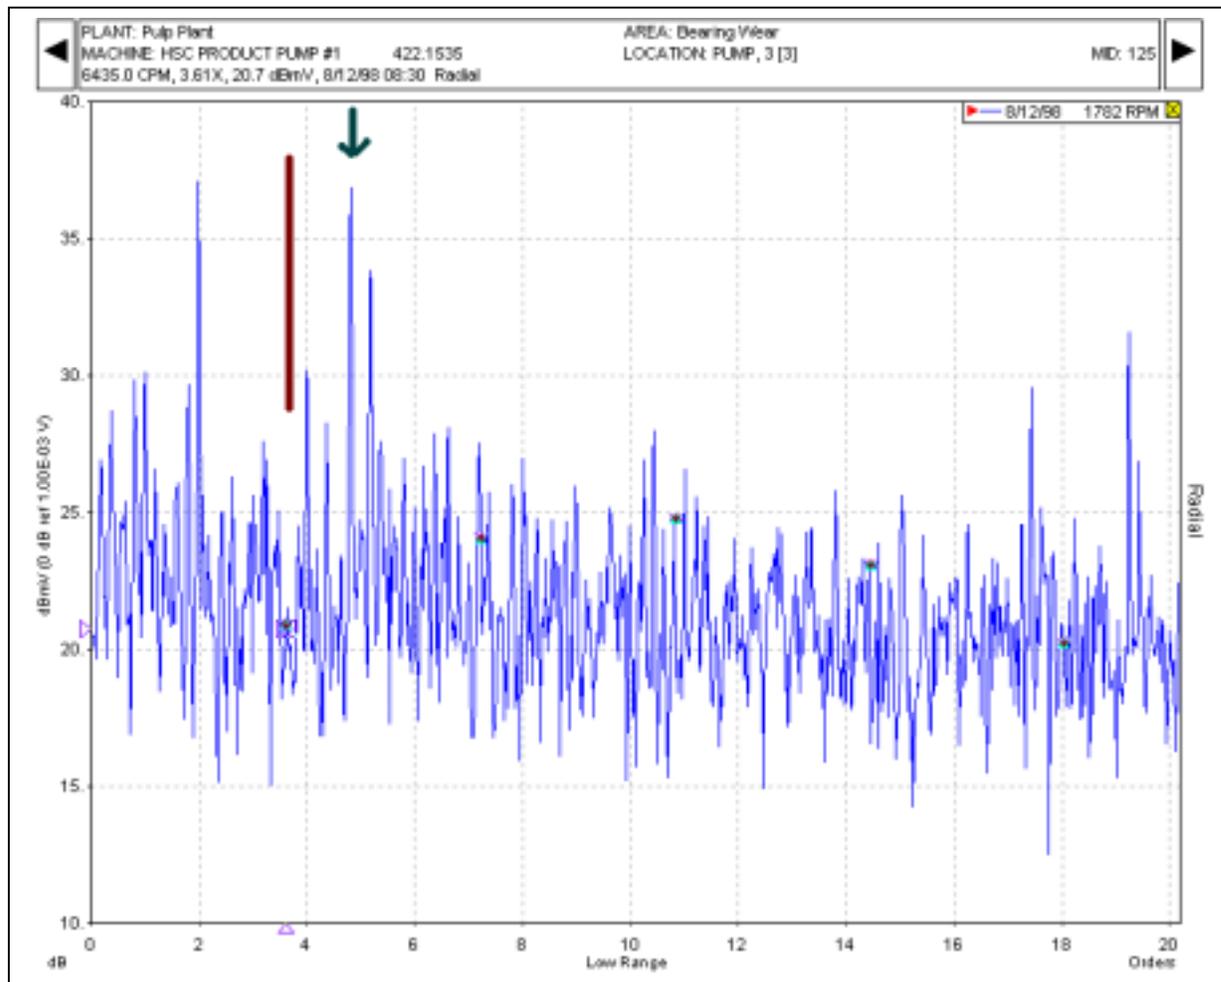
(Figure 4, Demodulated Data – Pump End)

In figure 4 (above), we have the demodulated data from the pump end of the machine. We can see here that there is no peak at 3.61x (marked in maroon) as there clearly was on the motor end demodulated data (figure 2). This is again due to the fact that the high frequency demodulated signal could not cross the coupling. Therefore, we now have confirmation that the fault is at the motor end.

There is a peak at 5.4x however, marked with a green arrow in figure 4. This is a distinct bearing tone on the pump end that is being detected in the demodulated spectrum. If we go back to the regular vibration data from the pump (figure 3), the peak at 5.4x cannot be found. This is because the demodulation technique is much more sensitive to bearing faults than the normal spectrum and therefore we can see these bearing tones in the demodulated spectrum before they have enough energy to appear in the regular spectrum. This does not mean the bearing must be replaced however, it simply means a small fault is in its initial stages of development.
